BK 2006-1889

UNITED STATES PUBLIC LAND SURVEY CORNER CERTIFICATE

Land Survey Monuments situated in Section 10, Township 95 North, Range 14 West, of the Fifth Principal Meridian, CHICKASAW County, Iowa.
 Previously recorded in NONE in County Recorder's Office.
(book, page, document number, etc.)

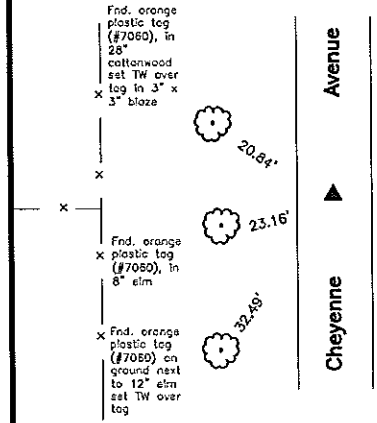
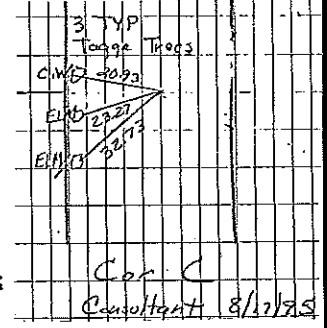
W $\frac{1}{4}$ Cor.

COR C	IRON PIN	1930	PIRCEC I P 33E OF TE COR. CORNER IT IN POST. IN CORNER
	Measured & dug 4' Down	Found Nothing	
	Set 60d Nail For Const Only		
			11-24-92

- 1930 - 'IRON PIN' per Co Engr's ties for Sec 9-95-14.
 - 1989, Nov. 4 - 'Spike Found' per Co Rec's Bk 143 Deeds, Pg 433.
 - 1992, 11-24 - 'Measured & dug 4' Down Found Nothing, set 60d Nail For const only' per Co Engr's ties for Sec 9-95-14.
 - 1195, 8-17 - 'SET $\frac{1}{2}$ " ϕ REBAR W/CAP 7060' per Co Rec's Bk 158, Pg 475.
 - 1995, 11-8 - 'Set $\frac{1}{2}$ " ϕ Rebar w/Cap' per Co Rec's Bk 159, Pg 318.
 - 2002, 10-22 - 'Fd. $\frac{1}{2}$ " ϕ Rebar w/ Orange Plastic Cap LS 7060' per Co Rec's Doc. 2002-2560.
 - 2004, 03-30 - 'Fd. PIN/CAP' per Co Rec's Doc. 2004-0788.
- Co Engr's previous records indicate that corner was monumented with 'IRON PIN and 60d Nail'.
Co Engr's current records indicate that corner is monumented with 'IRON PIN' with ties as shown above.

Corner Recovery = Searched area with metal detector and excavated 0.5' x 0.5' x 0.5' deep hole at cross of ties and found a $\frac{1}{2}$ " ϕ Iron rerod with orange cap remnants, flush with top 0.3' bent S. Tied out rerod and removed, searched again with metal detector and found a bent 60d spike, S25 $^{\circ}$ 48'50"E, 0.61' from rerod, 0.1' deep. Tied out and removed spike and searched again with metal detector and found nothing. Since Co Engr's ties indicate 60d spike was set for construction only, used position of straight portion of rerod. Straightened rerod and replaced in original location 0.4' deep, and placed plastic cap remnants on top. Straightened and replaced 60d spike in it's original location and drove to 0.6' deep. Rerod is 3.0' \pm W of centerline of gravel road N-S and in-line with fence line W and 33' \pm E of fence N-S. Location of monument found matches that of record, monuments found match that of record, and record ties are within reason. Therefore, used rerod as the correct corner. All ties are plumb distance unless indicated otherwise.

This certificate is being prepared because there are no longer three valid ties of record, and there is a change to monumentation of record.

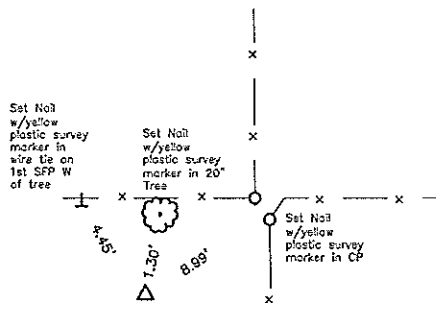
SE Cor. NE $\frac{1}{4}$ SW $\frac{1}{4}$

Co Engr's previous and current records do not indicate that corner is monumented.

Corner Recovery = Searched area with metal detector and excavated 1.0' x 1.0' x 0.5' deep hole at S side of old rotten CP and found orange flagging and a 16d nail laying flat. Probed all sides of old CP and hit rock pile around base, none of the rocks appeared to have been set as a corner monument. Therefore, since there is no available record of corner being monumented, set a 3/4" ϕ x 4.0' Alum capped (#14677) iron rerod stamped " $\frac{1}{4}$ $\frac{1}{4}$ Cor" to perpetuate monumentation on-line and equidistance from the S $\frac{1}{4}$ Cor and the Center of Section. Monument is 3.5' \pm S of fence line E-W and 8.5' \pm W of fence line N and 9.5' \pm W of fence line S. Rerod is flush. All ties are plumb distance unless indicated otherwise.

This certificate is being prepared because there are no certificates on file for this corner.

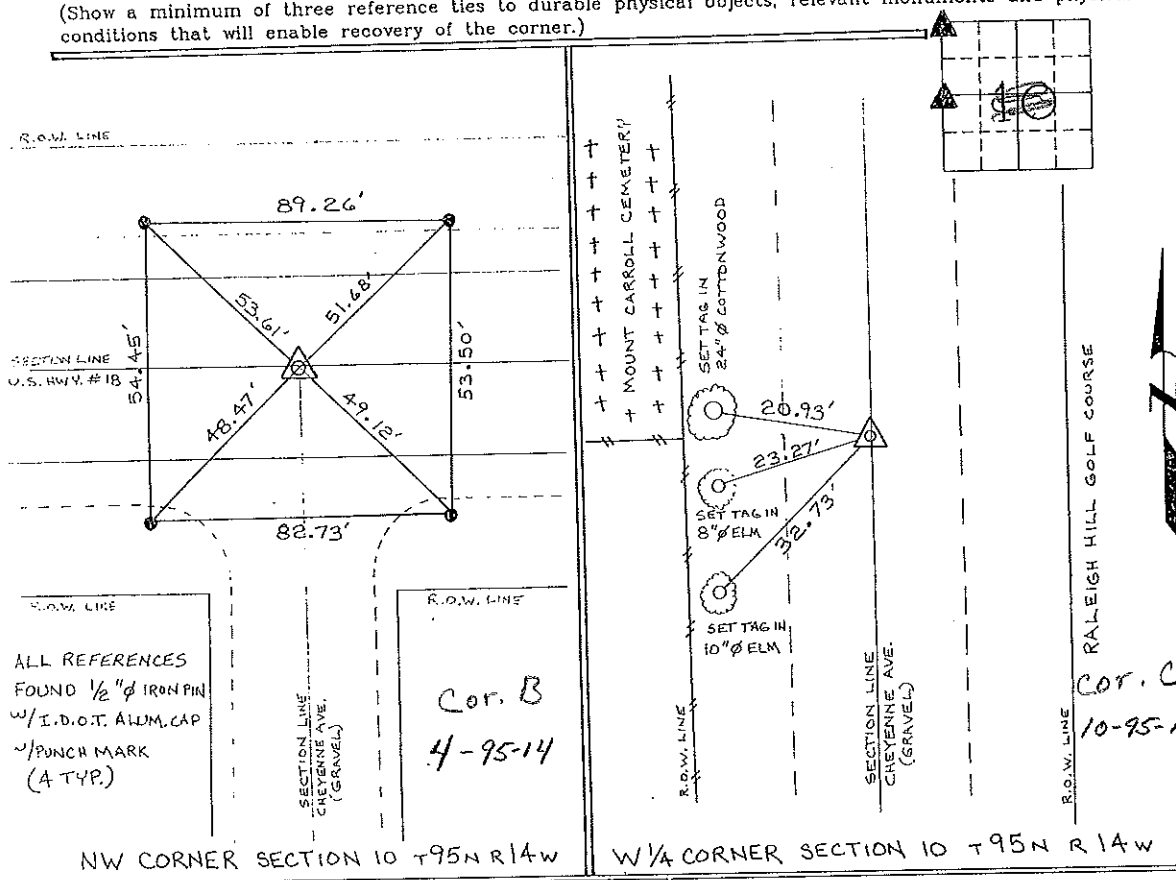
PLAN - VIEW

Monument Description and Remarks: NW CORNER SECTION 10 T95N R14W:
FOUND I.D.O.T. ALUMINUM MONUMENT @ JUNCTION OF U.S. HWY. 18 & CHEYENNE AVE.

W 1/4 CORNER SECTION 10 T95N R14W: SET 1/2" Ø REBAR W/CAP 7060 33 FT. EAST OF R.O.W. & EAST-WEST CORNER POST, INFORMATION AS TO PREVIOUS LOCATION FROM COUNTY ENGINEER'S RECORDS & PREVIOUS SURVEY.

ALL REFERENCES FOUND 1/2" Ø IRON PIN W/I.D.O.T. ALUM. CAP 1/4 PUNCH MARK (A TYP.)
